January 31, 1968

Final Report

INTERACTION OF LIQUID SODIUM WITH 304 STAINLESS STEEL

SRI Project PMU 6694

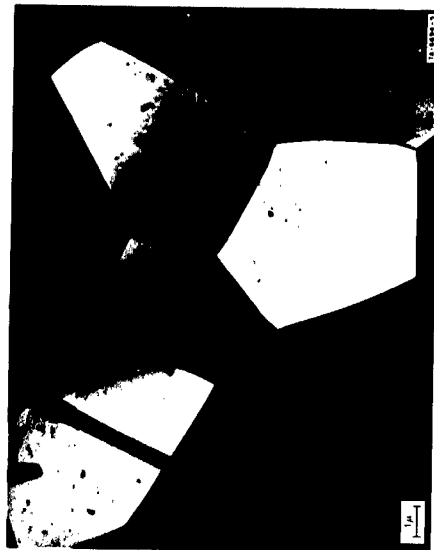
FIG. 5 TRANSMISSION ELECTRON MICROGRAPH OF 304 STAINLESS STEEL AFTER ELECTROPOLISHING

Electron micrographs of annealed 304 stainless steel foils, as electropolished, are shown in Figs. 5-7. The grains are generally equiaxed and the grain boundaries are well defined. The dislocation density in the foils is low, but numerous annealing twins are observed. The edges of the foils are very smooth after electropolishing (Fig. 6). These micrographs are typical of the 304 stainless steel foils used in all tasks of the experimental investigation.

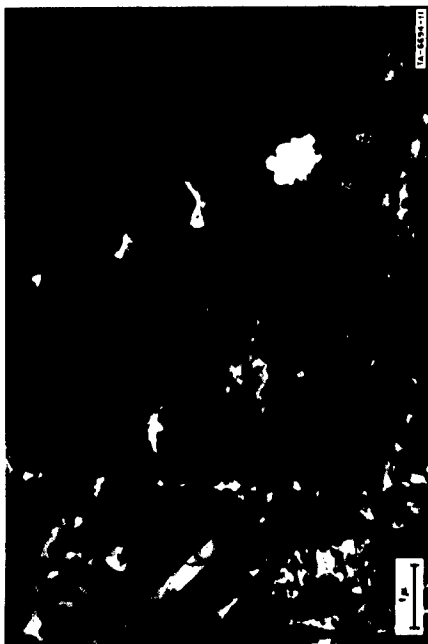
FIG. 11 TRANSMISSION ELECTRON MICROGRAPH OF 304 STAINLESS STEEL FOIL AFTER THREE HOURS EXPOSURE TO LIQUID SODIUM AT 1200°F. This higher magnification micrograph of the area shown in Fig. 10 shows the grain boundary attack more clearly.

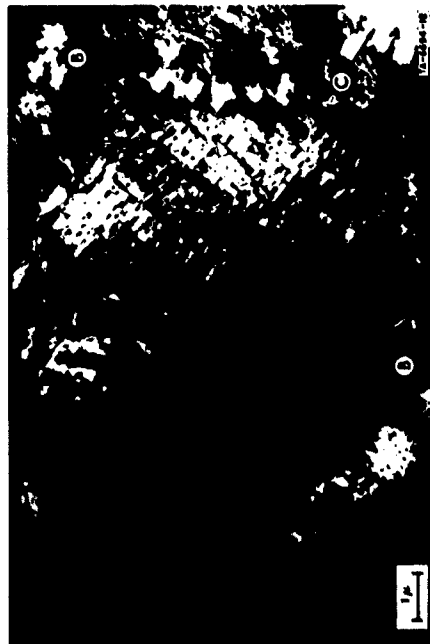
FIG. 12 TRANSMISSION ELECTRON MICROGRAPH OF 304 STAINLESS STEEL FOIL AFTER THREE HOURS EXPOSURE TO LIQUID SODIUM AT 1200°F. Micrograph reveals severe grain boundary attack along several boundaries (B) and etching of hole (C).

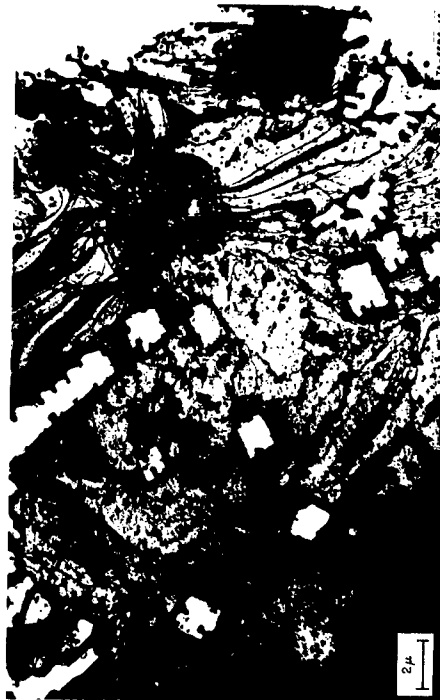
FIG. 14 TRANSMISSION ELECTRON MICROGRAPH OF 304 STAINLESS STEEL FOIL AFTER FIFTEEN HOURS EXPOSURE TO LIQUID SODIUM AT 950°F. Micrograph shows holes etched in surface by liquid sodium. The very ragged edge of the foil has also been severely attacked.

deposited on almost all the grains, appears dark because it is thick enough to absorb all the electrons that otherwise would pass through the foil. The deposit always has a geometrical shape, which varies from grain to grain, often a grain is heavily deposited, but a twinned section of the same grain is relatively free of deposit. So far it has not been possible to identify this deposit by transmission electron diffraction. In view of the fact that stainless steel foils can be cleaned so successfully after exposure to liquid sodium at and below 700°F, it is felt that this precipitate is neither sodium nor sodium oxide. One grain boundary shown in Fig. 10 has been attacked by the liquid sodium. Rather large holes with very ragged edges can also be seen in this micrograph. These holes may well have been small pinholes in the electropolished foil (Fig. 6) that have been enlarged by attack of the liquid sodium metal. The grain boundary attack can be more clearly seen in Fig. 11, which is a higher magnification micrograph of the same area of the foil. Only a few of the grain boundaries were attacked, but no detailed orientation studies were made to determine which boundaries were involved. Figs. 12 and 13 reveal grain boundaries that have been severely attacked, leaving the edges with the characteristic ragged effect. This etching behavior is always observed at the edges of the foil: thus, a very smooth edge (Fig. 7) becomes ragged and irregular after exposure to liquid sodium at 1200°F (Figs. 14 and 15).

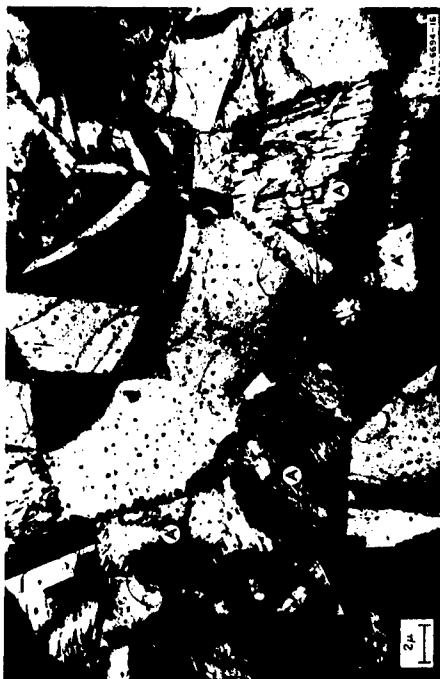
FIG. 16 TRANSMISSION ELECTRON MICROGRAPH OF 304 STAINLESS STEEL FOIL AFTER ELEVEN HOURS EXPOSURE TO LIQUID SODIUM AT 1200°F. A preferential deposit along grain boundaries is evident throughout. Sections of some grains have fairly heavy surface deposits (A), whereas twinned sections of the same grains are relatively clean (A').

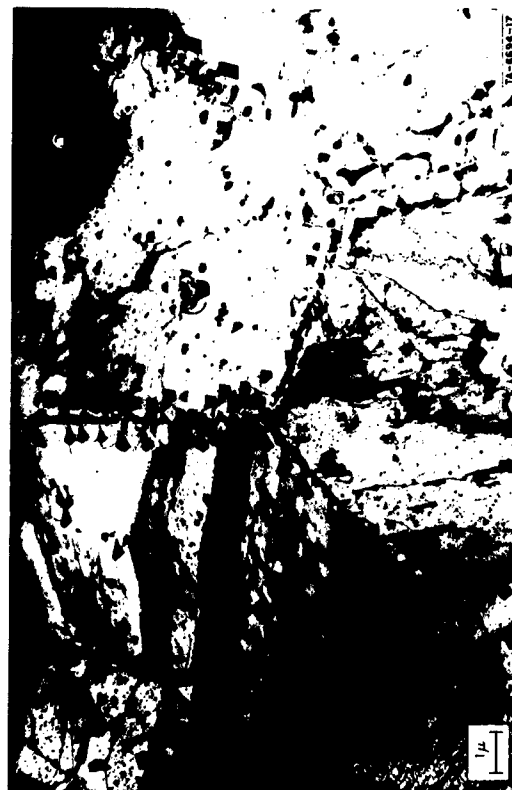
FIG. 17 TRANSMISSION ELECTRON MICROGRAPH OF 304 STAINLESS STEEL FOIL AFTER ELEVEN HOURS EXPOSURE TO LIQUID SODIUM AT 1200°F. Micrograph clearly shows geometrical grain boundary precipitate.

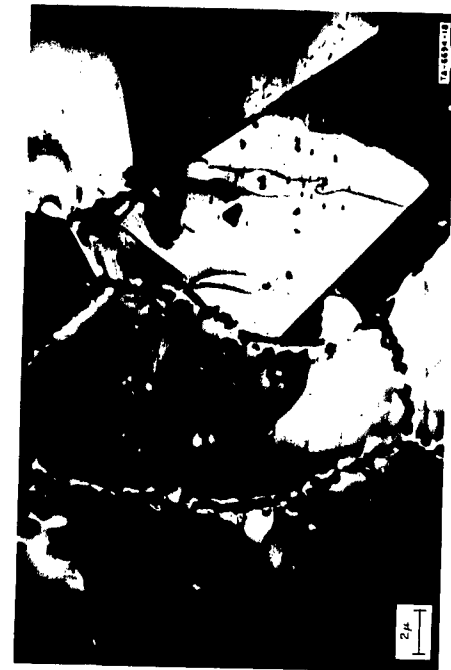
FIG. 18 TRANSMISSION ELECTRON MICROGRAPH OF 304 STAINLESS STEEL FOIL AFTER ELEVEN HOURS EXPOSURE TO LIQUID SODIUM AT 1200°F. Structure shows selective grain boundary precipitate. Note that the twin boundaries are free of deposit.

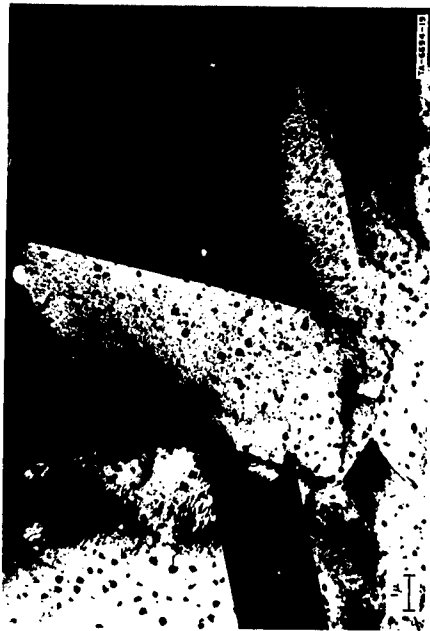
FIG. 19 TRANSMISSION ELECTRON MICROGRAPH OF 304 STAINLESS STEEL FOIL AFTER FIFTEEN HOURS EXPOSURE TO LIQUID SODIUM AT 950°F. Surfaces and grain boundaries are relatively free of deposit.

Fig. 19 shows a region of an exposed foil that is relatively free of both surface and grain boundary deposit, compared with the structure in Fig. 20. Foils such as that in Fig. 19 have, after initial cleaning and examination, received a second and more vigorous cleaning without reducing the amount of deposit observed. Variations in surface deposits therefore are not solely attributable to the efficiency of the cleaning technique.

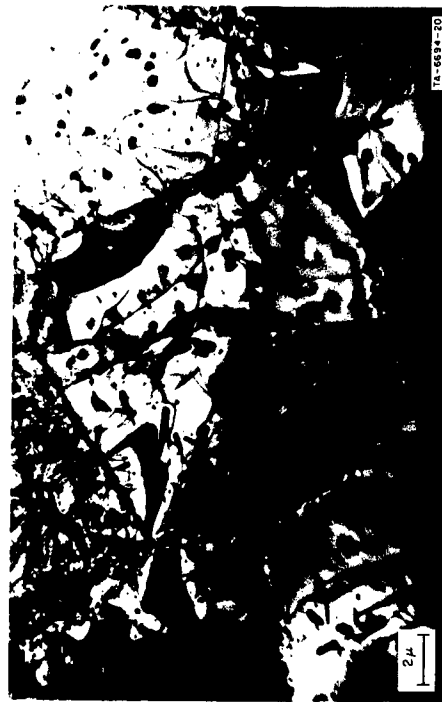
FIG. 20 TRANSMISSION ELECTRON MICROGRAPH OF 304 STAINLESS STEEL FOIL AFTER SIX HOURS EXPOSURE TO LIQUID SODIUM AT 1200°F. Heavy deposits occur on surface and at grain boundaries.
